Information Request to SKF USA Inc.

PE02-088

Failure Analysis on specially selected Meritor THUs from the Field.

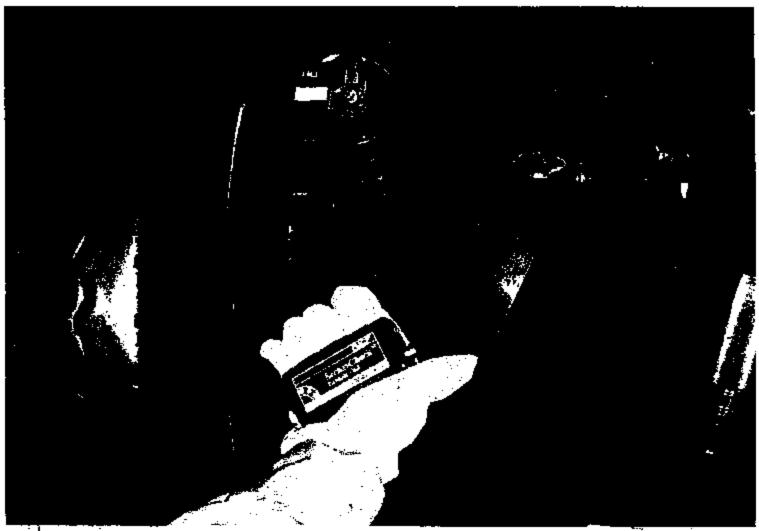
Electronic Inspection Device in Use

- Electronic detection method chosen and validated; hurdle value established
- Effectiveness of TP-0251 confirmed (however not as sensitive as the electronics)
- Field population characterization confirmed TP-0251, but results indicated that the special cause of progressive events was not uncovered.
- Phase 1 completed on 366 trucks at one fleet, with results suggesting that inspection practices needed to be investigated. Consequently, Phase 2 investigation was conducted at other fleets.

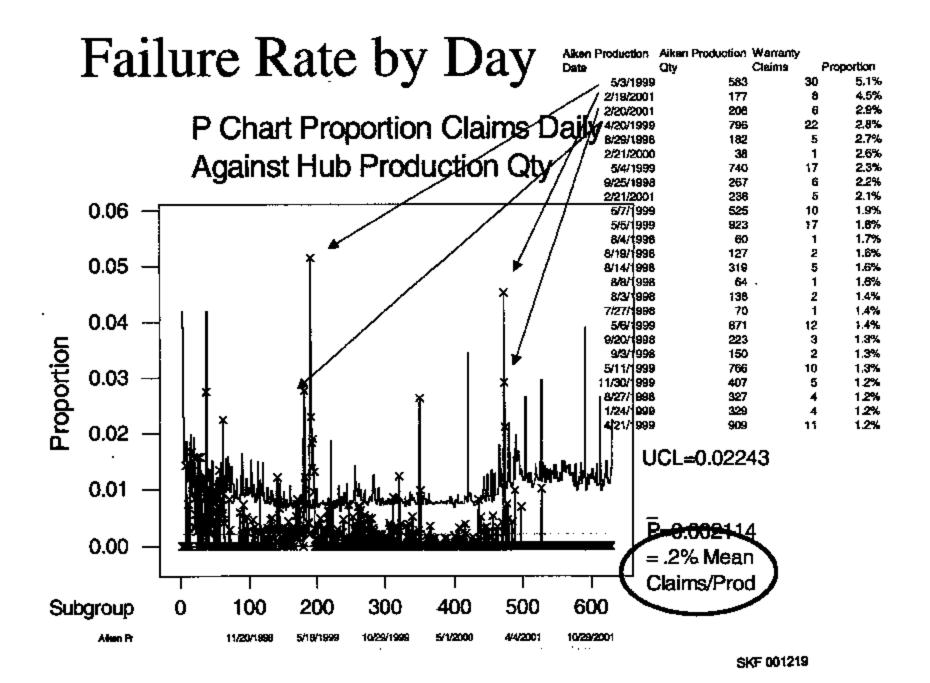
April/May 1999
Investigation Results

From the results of the investigations it could be concluded that the high number of claims for the production period of April/May 1999 were caused by an incorrect final operation in surface finishing of the outer ring raceways.

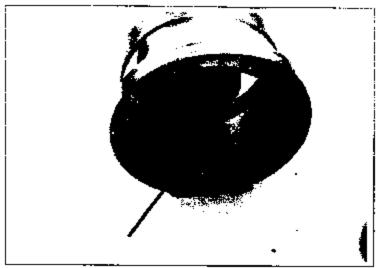
Darkened red area on bore (0°)

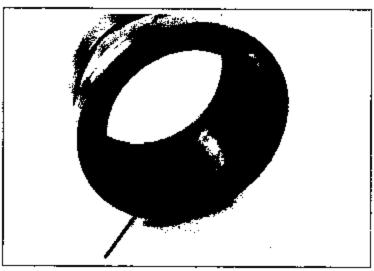
Light red area on bore (180°)

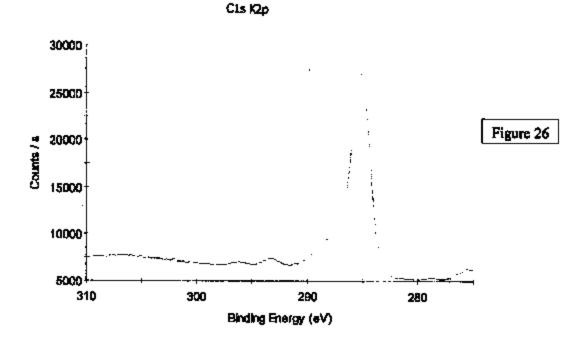
SKF04 Non-discoloured area on chamfer

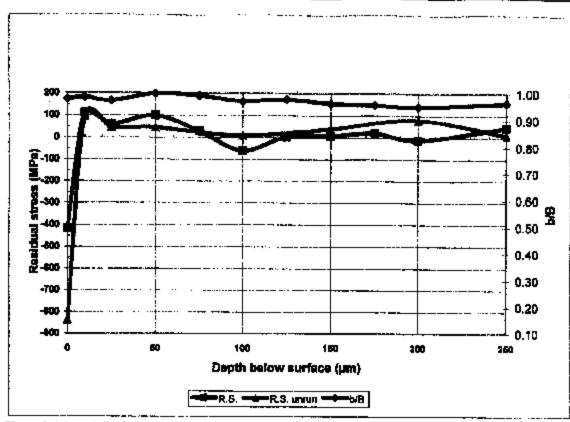
Figure 3. Inboard IR of unit 918279

Figure 3 shows the residual stress profile of the unum IR, which was used as a baseline for all IR measurements. The profile has a high compressive stress at the surface (depth = zero) which is typical and due to the hard machining operations performed after hardening. The residual stress becomes tensile at a depth of 10 µm, which would be expected in a marteneitically through hardened ring. At deeper depths, the profile is basically neutral. Figure 3 also shows the residual stress profile of the inboard IR of unit 918279 and it should be noted that this profile was measured in the centre of the raceway. There is a compressive stress at the surface and the remainder of the profile basically follows the unrun profile, with some deviation, either due to the application conditions or the accuracy of the measurement (± 50 MPa). This figure also shows the 'b/B' ratio, which is a comparison of the line broadening of the IR of unit 918279 used in the application with the unrum IR. It can be seen that the b/B ratio is relatively high, never dropping below 0.95. By definition, the b/B ratio has a maximum value of 1.0 and the profile shown in figure 3 would indicate that very little fatigue. damage can be observed to the centre of the inboard IR. from unit 918279.

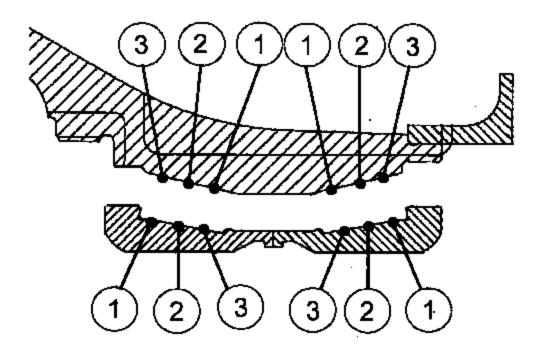
Figure 4. Indication of the measurement positions in the x-ray analysis investigation

Unit 918279 had run for 569,184 miles. It was decided to investigate the longest running unit i.e. 918287 which had run for 591,711 miles. As a further refinement, it was decided to measure the profiles in three positions on the raceway, as illustrated in figure 4. For the IRs, measured in the highest loaded zone, Position 2 was the sentre of the raceway (13 mm), Position 1 was at the thicker section (13 mm + 6 mm) and Position 3 was at the thinner section (13 mm - 6 mm). For the ORs, the same three positions were measured, with Position 2 at the centre of the raceway (13 mm), Position 1 at the thicker section (13 mm + 6 mm). For

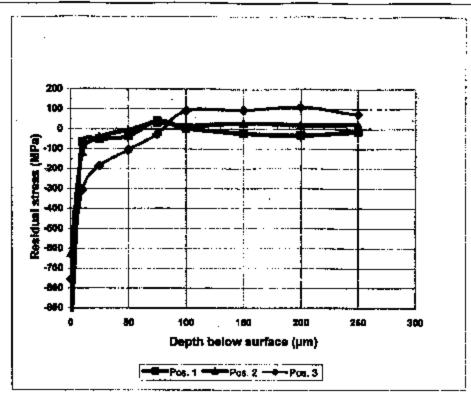
Figure 5. Inboard IR of unit 918287

The residual stress profiles and b/B ratio of the inboard IR are thown in figures 5 and 6 with the equivalent results for the outboard IR shown in figures 7 and 8. As before, the results were compared with the profile from the unrun IR. Pigure 5 shows evidence of material response in the near surface region. This was evident in Position 3 and can be seen by the generation of a compressive stress at depths to around 75 um. The generation of compressive stresses at the near surface in Position 3 indicates some material response in this region but the high values of b/B (>0.9) in figure 6 show that there was only a limited accumulation of fatigue. At desper depths on all three profiles, and as shown by the b/B ratio in 6, there is no evidence of a response to the sub-surface Hertzian contact stress and, hence, no indication of classic sub-surface RCF fallure in this unit. Figures 7 and 8 for the outboard IR of this unit do not indicate any evidence of the accumulation of either surface. or sub-surface fittigue as the profiles do not differ significantly from the unrun IR and the b/B ratio remains at a high level i.e. above 0.90.

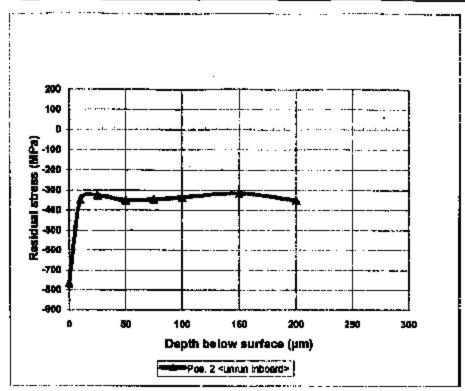
Figure 9. Inboard receway of OR of new, unrun THU (02MR0019)

The beseline measurements for the OR receways of new, unrun unit are abown in figures 9 and 10. In figure 9, it can be seen that the inboard recoway has a high compressive stress at the surface (depth = zero) due to the bardmachining processes. At deeper depths, the residual stress is compressive, as would be expected in a surface induction hardened component, and the stress has a magnitude of 300 to 350 MPs. For the outboard raceway, the residual stress profile, figure 10, has the same characteristics as that of the inboard receway except that the magnitude of the compressive stress in the induction hurdened surface shows more varietion and tends to have a lower value. This difference in residual stress is likely to stern from slight differences in the induction hardening and tempering process. This is also indicated by the line broadening measurements, which also show a slight difference. The inboard raceway had a line broadening value of approximately 7.5 while the outboard raceway had a value of approximately 8.0.

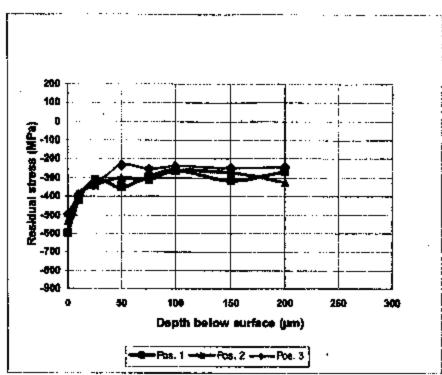
Figure 11. Inboard raceway of OR of unit 918287

Figure 11 shows the residual stress profiles in the three positions on the inboard raceway. The magnitude of the compressive stress at the surface (depth = zero) is slightly lower than that measured in the unrun unit. At the second measurement position, at a depth of 10 µm, all three profiles show a slightly higher magnitude of compressive stress as compared to the new, unrun unit at the same depth. This would indicate some material response in this region but the relatively high values of b/B, in figure 12, show that there was only a limited accumulation of fatigue damage. At deeper depths, the profiles do not show any strong

features, with compressive stresses of the order of 250 to 300 MPa. The b/B profiles for the inboard raceway are shown in figure 12 and these indicate only a limited response to RCF as the values tend to be high, lying between 0.90 and 1.0. It is noted that the lowest b/B values are at the surface.

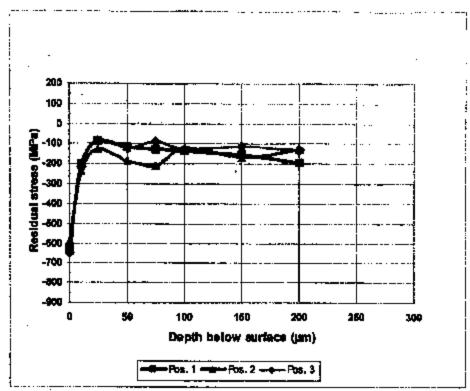
Figure 13. Outboard raceway of OR of unit 918287

The residual stress profiles and b/B profiles for the inboard and outboard raceways of the OR of unit 918287 are shown in figures 11 to 14.

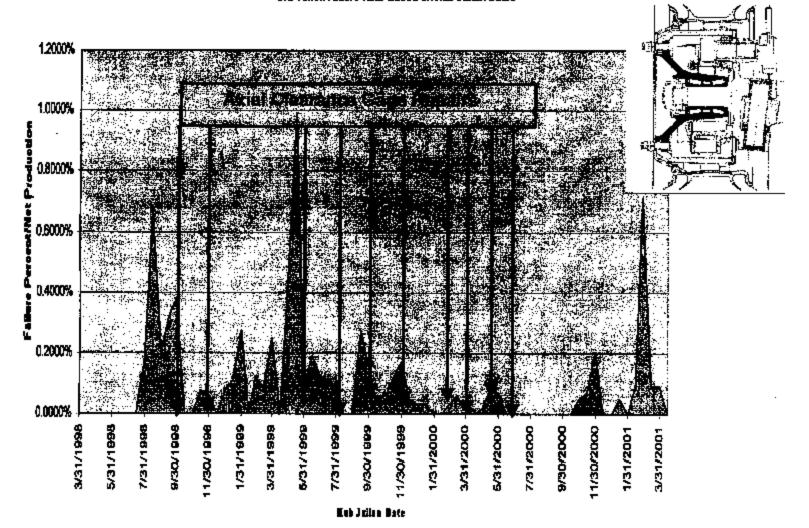
ArvinMeritorAxial Clearance

SKF Aiken Faiture Rate Based on Hub Julian Dates

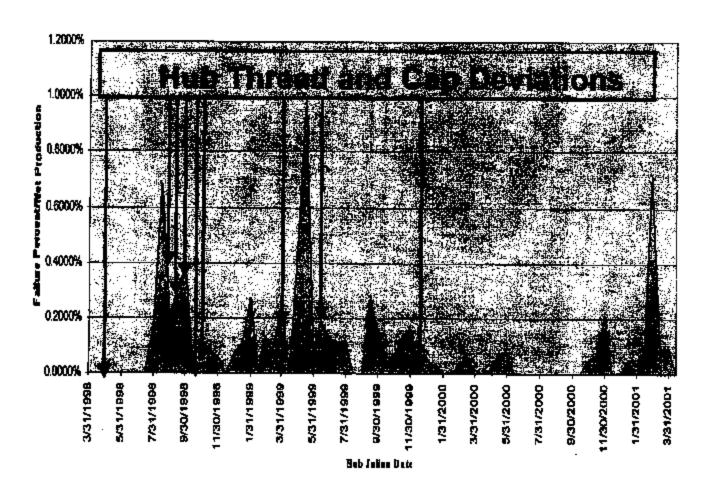
Hub Cap & Threads

SKF Alken Fallure Rate Based on Hub Julian Dates

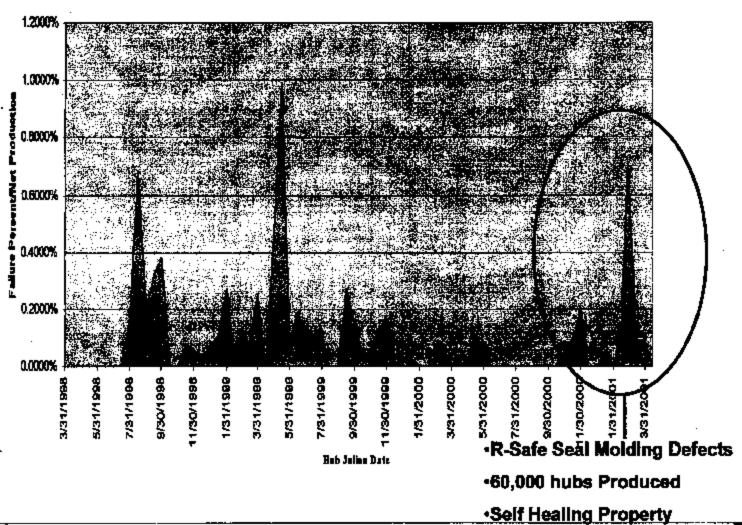
ArvinMeritorR-Safe Seal

SKF Aiken Failure Rate Based on Hub Julian Dates

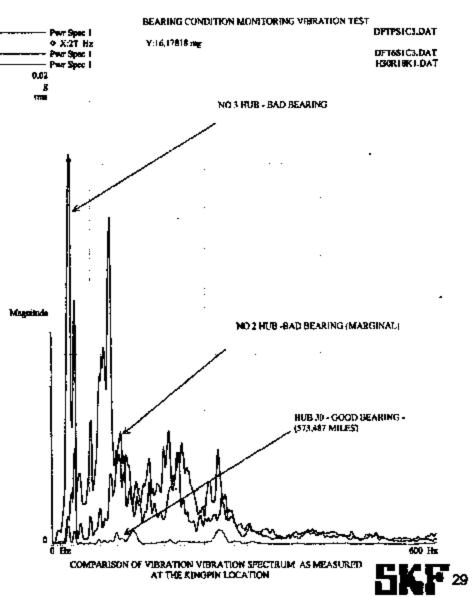
Vibration Characteristics

- Shows differentiation good unit vs. damaged
 - Most activity in lower frequency ranges
 - Scale of readings is small

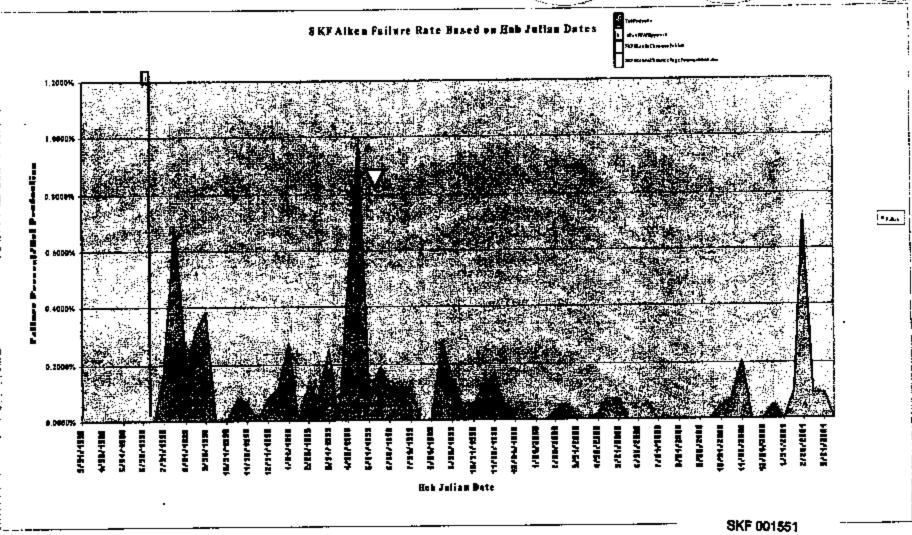
Alken Launch SKF Returned Parts

- Water
- ·Launch Issues / High Scrap Rate at SKF Aiken
- Hub Cap Deviations Missing Hub Caps

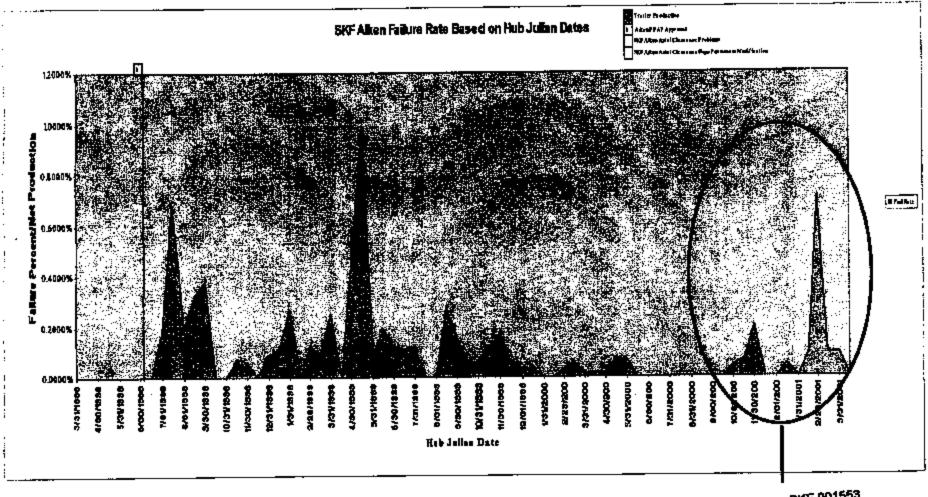
Axial Clearance Gauge

- October 31, 1998 Axial Clearance Gage air leak found
 Corrective Action Repaired Leak (October 31, 1998)
- January 21, 1999 Axial Clearance Gage Diaphragm failure
 Corrective Action Replaced Diaphragm and quarantined approximately 2,000 bearings (January 21, 1999)

- May 31, 1999 Axial Clearance Gage Diaphragm failure
 Corrective Action Replaced Diaphragm (May 31, 1999)
- August 20, 1999 Bearing webbles when rotated
 Corrective Action Axial Clearance Gage upper and lower bearings were replaced (August 20, 1999)

- October 6, 1999 Changed Mounting of Diaphragm to reduce wear
- January 7, 2000 Axial Clearance Failure
 Corrective Action Replaced Diaphragm (January 7, 2000)

- February 29, 2000 Axial Clearance Gage Diaphragm replaced
 Corrective Action Replaced Diaphragm (February 29, 2000)
- March 31, 2000 Axial Clearance Gage retrofitted with new cylinder design replacing diaphragm.

- April 27, 2000 —Centering Ball broke off of lower tooling:
 Corrective Action Aligned Shaft (April 27, 2000)
- June 6, 2000 Axial Clearance Gage upper and lower bearings were replaced

Permanent Corrective Actions - Aug 20 1999
 5KF

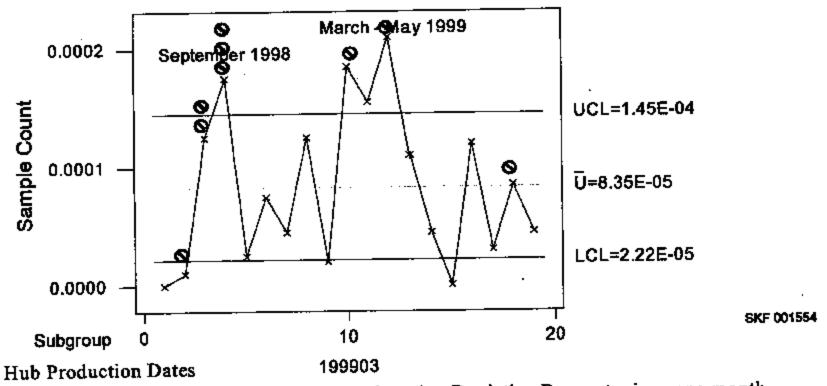
u Chart Count of Claims Vs Monthly Production Steer Claims Only

Seal Molding Defect Rate < 2 % Total Seals Manufactured 88,703

Correlation study of hubcaps under deviation with high warranty periods

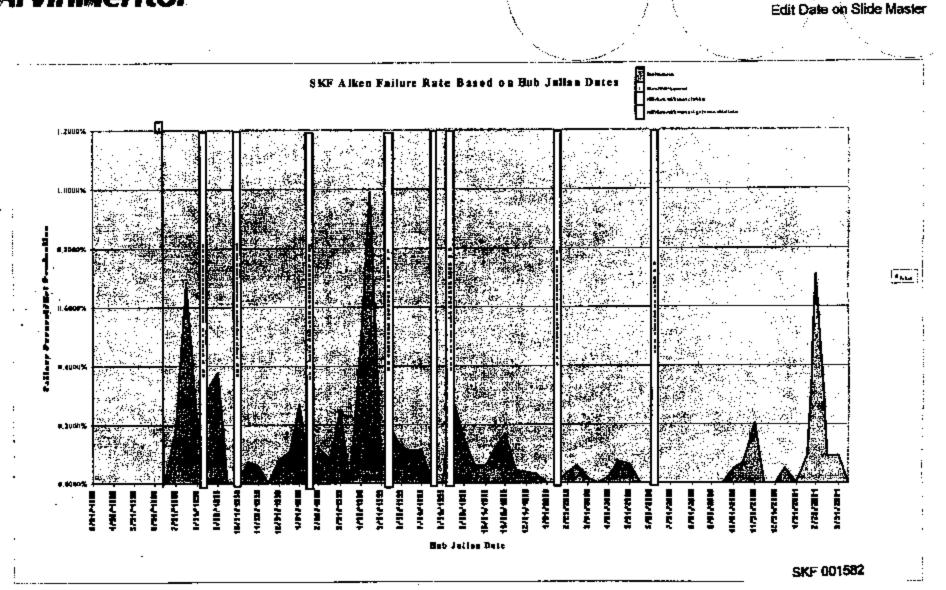
Axial Clearance Gauge

- October 31, 1998 Axial Clearance Gage air leak found
 Corrective Action Repaired Leak (October 31, 1998)
- January 21, 1999 Axial Clearance Gage Diaphragm failure
 Corrective Action Replaced Diaphragm and quarantined approximately 2,000 bearings (January 21, 1999)

- May 31, 1999 Axial Clearance Gage Diaphragm failure
 Corrective Action Replaced Diaphragm (May 31, 1999)
- August 20, 1999 Bearing wobbles when rotated
 Corrective Action Axial Clearance Gage upper and lower bearings were replaced (August 20, 1999)

- October 6, 1999 Changed Mounting of Diaphragm to reduce wear
- January 7, 2000 Axial Clearance Failure
 Corrective Action Replaced Diaphragm (January 7, 2000)

- February 29, 2000 Axial Clearance Gage Diaphragm replaced Corrective Action – Replaced Diaphragm (February 29, 2000)
- March 31, 2000 Axial Clearance Gage retrofitted with new cylinder design replacing diaphragm.

- April 27, 2000 —Centering Ball broke off of lower tooling Corrective Action — Aligned Shaft (April 27, 2000)
- June 6, 2000 Axial Clearance Gage upper and lower bearings were replaced

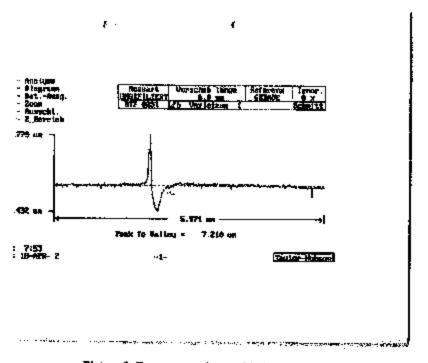
The extension of the indentation in picture 2 was determined to be 0.35 mm in circumferential direction and approximately 7.2 µm from peak to valley (picture 3).

Picture 3: Receway surface and indentation

This test proves that non rotation of the THU outer ring during clamping can cause considerable damage of the bearing. This kind of damage is considered to be detrimental to the bearing performance.
